Big Bar Landslide

North of Big Bar on the Fraser River

July 25, 2019

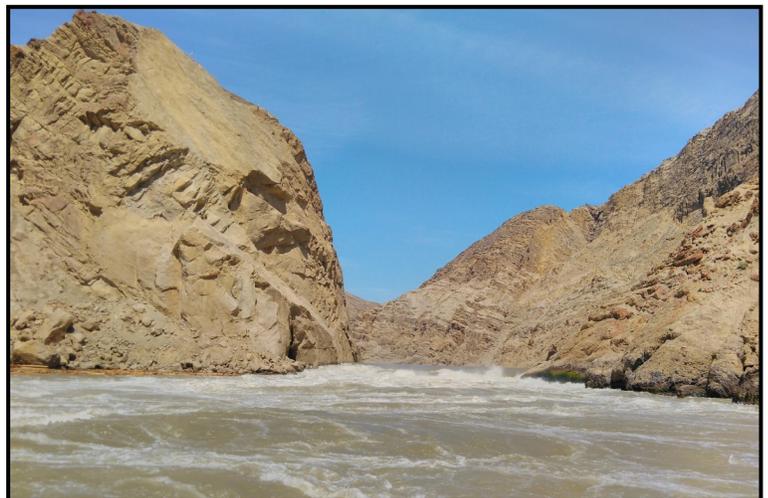
- On Tuesday, Canadian Coast Guard personnel and river specialists were on the Fraser River, downstream of the slide location, to assess water flow and conditions. Water conditions were found to be extremely hazardous due to the erratic and fast moving current.

Figure 1. Extremely rough conditions on the Fraser River, near the landslide incident location.
