## Big Bar Landslide Rock Scaling Operations

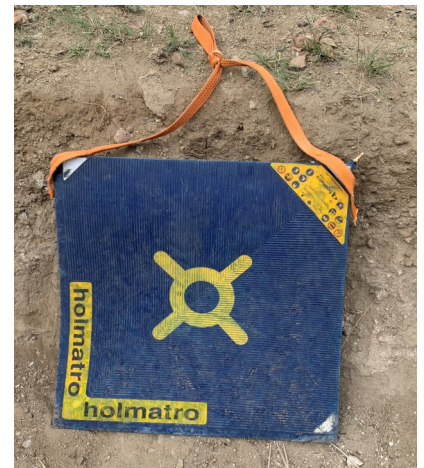
- The rock scalers remove loose rock through manual manipulation using a pry bar. Rock scalers are assisted by helicopters that drop water to sluice loose debris. On larger rocks, rubberized air bags, as pictured right, are placed between rock joints and inflated with compressed air to dislodge unstable the rock.

Rubberized air bag. Size: approximately 0.6 metre by 0.6 metres.

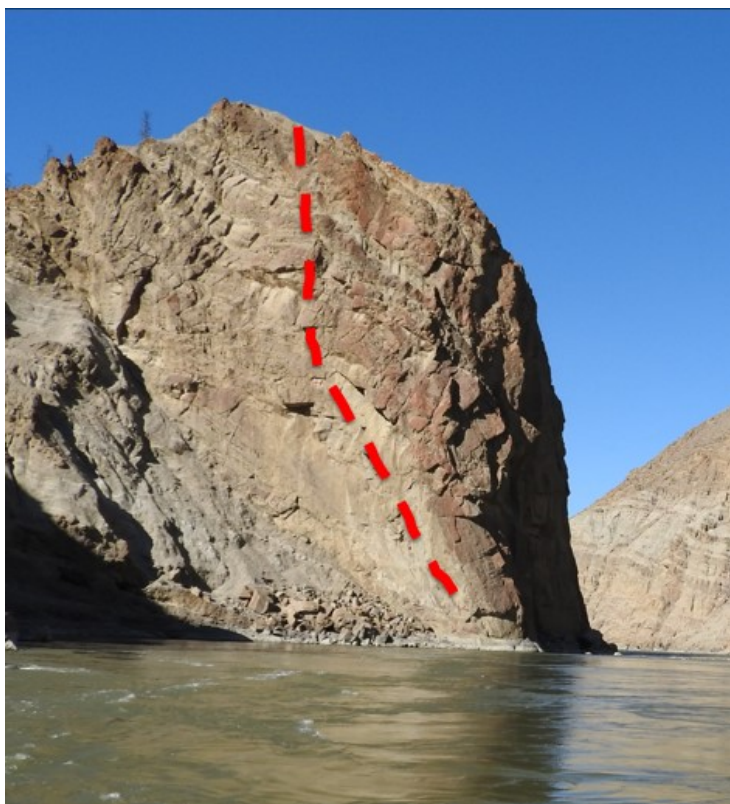
- The pre landslide photo taken in the Fall of 2017, pictured bottom left, depicts the sheer magnitude of the rockslide.
- For perspective, as pictured bottom right, the vertical height of the cliff face is approximately 125 metres. Landslide rock and debris has submerged below impeding salmon migration upstream to spawning grounds.

The rock prior to slide.

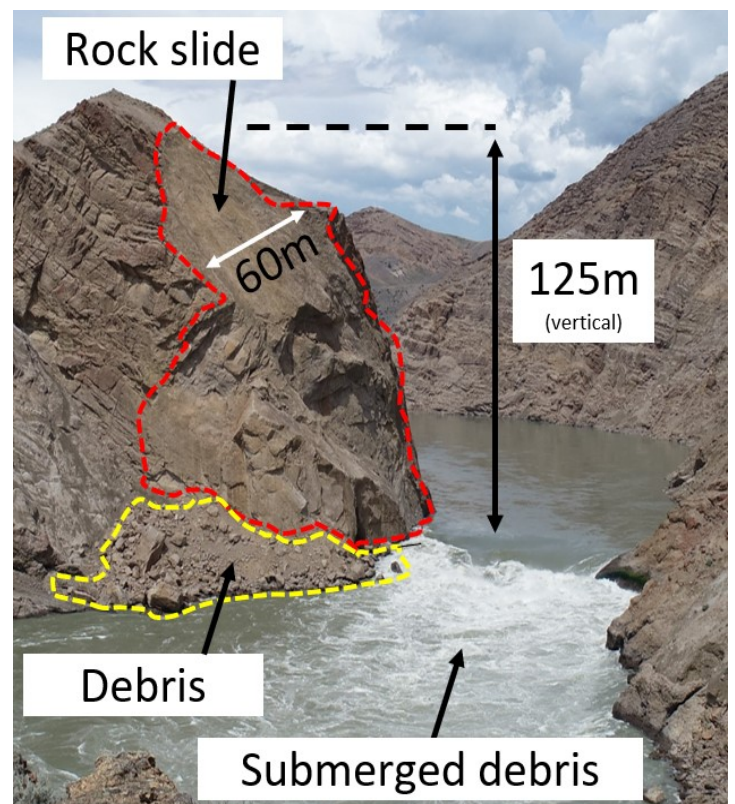
Scale of the landslide site, for perspective.
